**Flood Control Project Maintenance  
Levee Inspections**

## Maintenance Issue Types Only, Levee Inspection Report By Mile - Spring 2016

### Sacramento Maintenance Yard Sacramento Bypass

Waterway	Bank	Unit Miles	Inspection Start/End	Inspector
Unit No. 01 Sacramento Bypass or North Levee	Right	1.74	03/02/2016 03/02/2016	Jai Lor

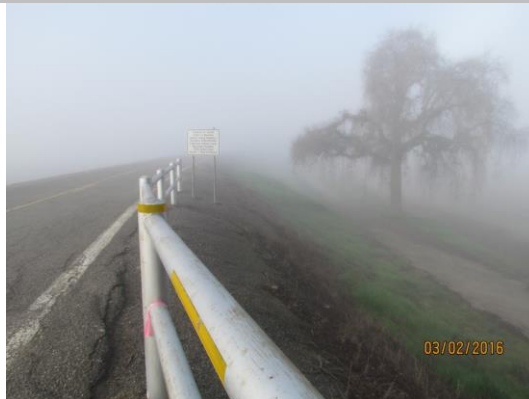
Photo 1 of 1 : SP\_2016\_ST0008\_284\_6\_20160303\_00010.jpg

LM Start	0.01	Rating **	A	Issue No.	6
LM End	0.51	Issue Type +	Ma	Location *	LS
Category	Earthen Levee			GPS Latitude/Longitude	
				Start	End
Item	Vegetation			38.607238 °	38.604474 °
				-121.560280 °	-121.568704 °
DWR ID	DWR_ST0008_01_s_2016_6				
Comment Code					
V1 : Control annual grass and weeds on the levee slopes and easements.					
Inspector Comment					
LMA has maintained slope vegetation.

View of the vegetation on the landward side of the levee looking downstream. Spring 2016.

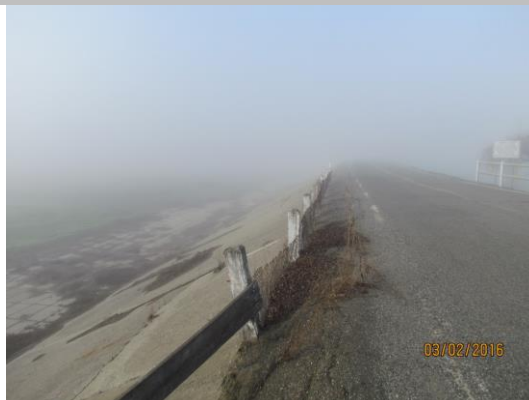
Photo 1 of 1 : SP\_2016\_ST0008\_284\_7\_20160303\_00011.jpg

LM Start	0.01	Rating **	A	Issue No.	7
LM End	0.51	Issue Type +	Ma	Location *	WS
Category	Earthen Levee			GPS Latitude/Longitude	
				Start	End
Item	Vegetation			38.607237 °	38.604474 °
				-121.560280 °	-121.568704 °
DWR ID	DWR_ST0008_01_s_2016_7				
Comment Code					
V1 : Control annual grass and weeds on the levee slopes and easements.					
Inspector Comment					
LMA has maintained slope vegetation.

View of the vegetation on the waterward side of the levee looking downstream. Spring 2016.

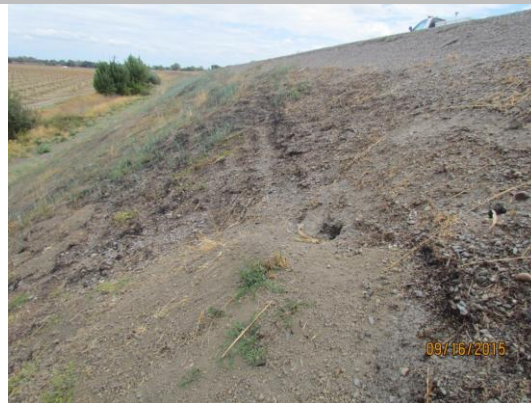
Photo 1 of 1 : SP\_2016\_ST0008\_284\_10\_20160302\_00003.jpg

LM Start	0.94	Rating **	M	Issue No.	10
LM End	0.94	Issue Type +	Ma	Location *	LS
Category	Earthen Levee			GPS Latitude/Longitude	
				Start	End
Item	Animal Control			38.602763 °	38.602763 °
				-121.576288 °	-121.576288 °
DWR ID	DWR_ST0008_01_f_2015_10				
Comment Code					
A3 : No rodents visible, but rodent burrows visible; need to backfill and compact or grout burrows.					
Inspector Comment

View of the rodent holes on the landward side of the levee looking upstream. Fall 2015.

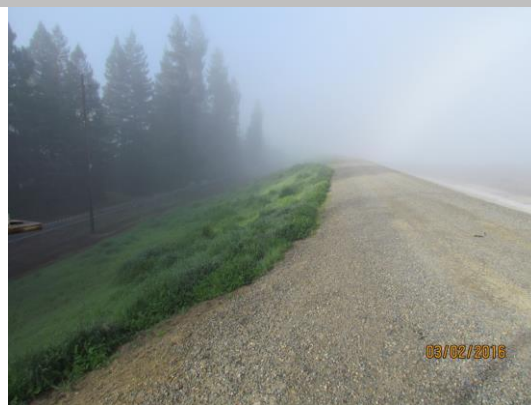
Photo 1 of 1 : SP\_2016\_ST0008\_285\_3\_20160303\_00001.jpg

LM Start	0.03	Rating **	M	Issue No.	3
LM End	0.48	Issue Type +	Ma	Location *	LS
Category	Earthen Levee			GPS Latitude/Longitude	
				Start	End
Item	Vegetation			38.602594 °	38.600476 °
				-121.556102 °	-121.563838 °
DWR ID	DWR_ST0008_02_s_2016_3				
Comment Code					
V1 : Control annual grass and weeds on the levee slopes and easements.					
Inspector Comment

View of the vegetation on the landward side of the levee looking downstream. Spring 2016.
